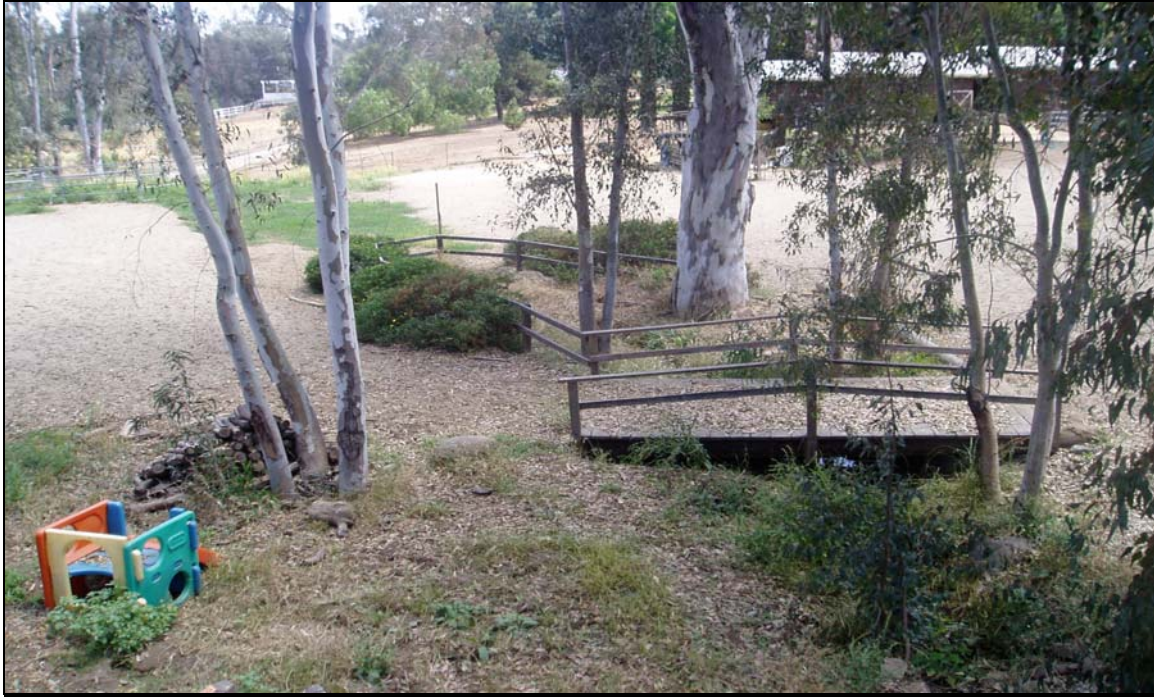
Photo Point 7. View of unnamed tributary of Escondido Creek south of Kauana Loa Drive (16 June 2005).

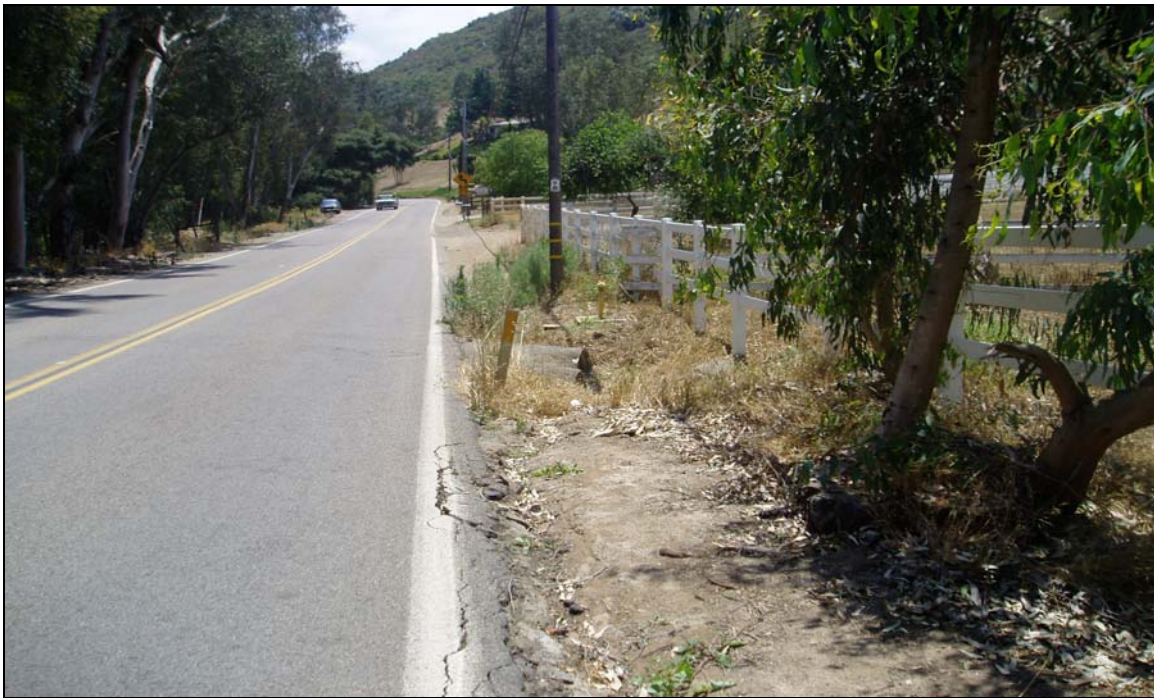
Photo Point 8. Road culvert for the unnamed tributary of Escondido Creek west of Harmony Grove Road (16 June 2005).

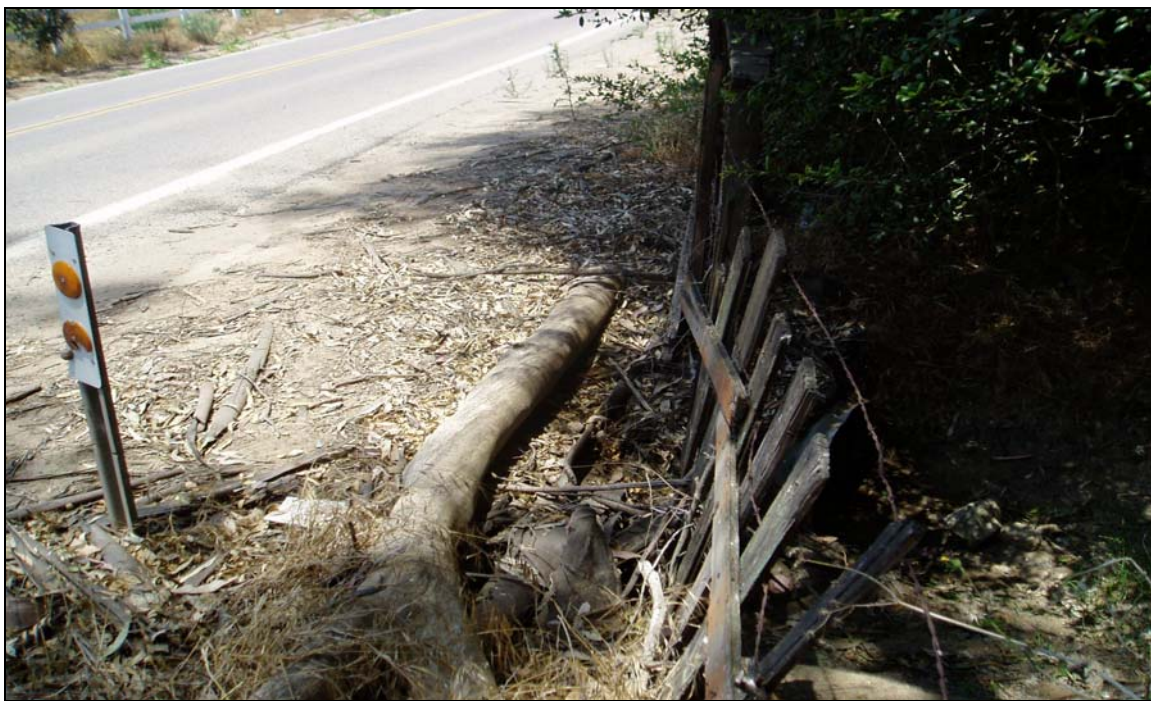
Photo Point 9. Road culvert for unnamed tributary of Escondido Creek east of Harmony Grove Road (16 June 2005).

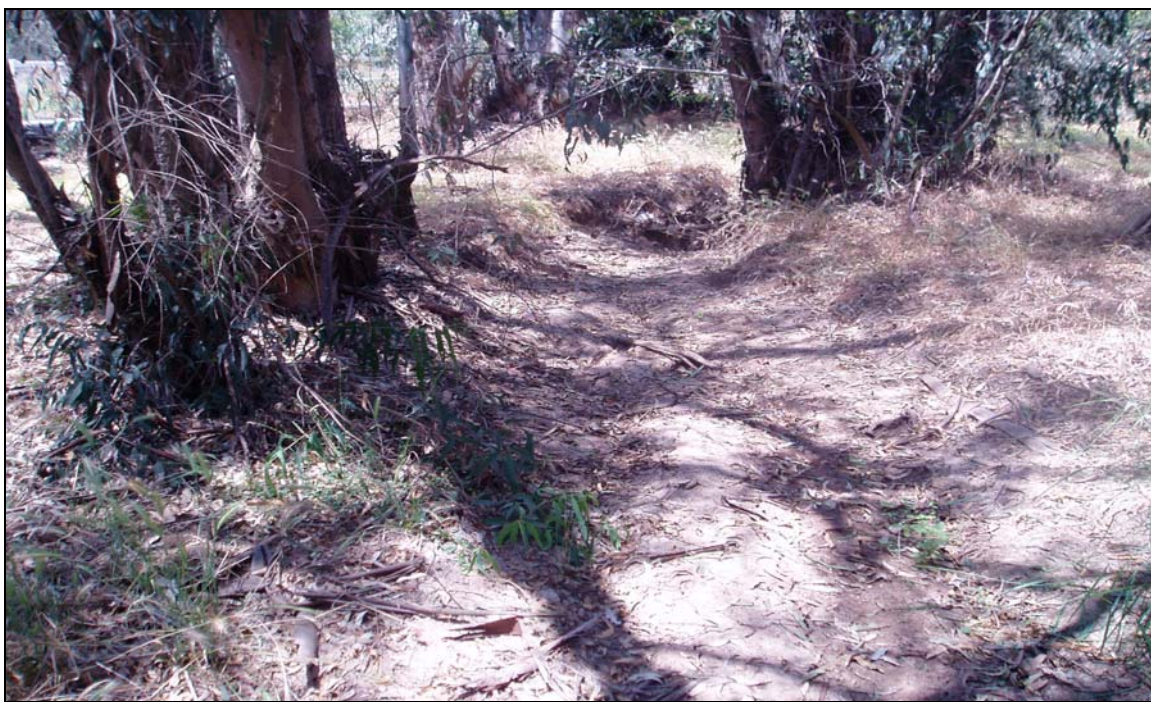
Photo Point 10. View of unnamed tributary of Escondido Creek between Harmony Grove Road and Escondido Creek (16 June 2005).

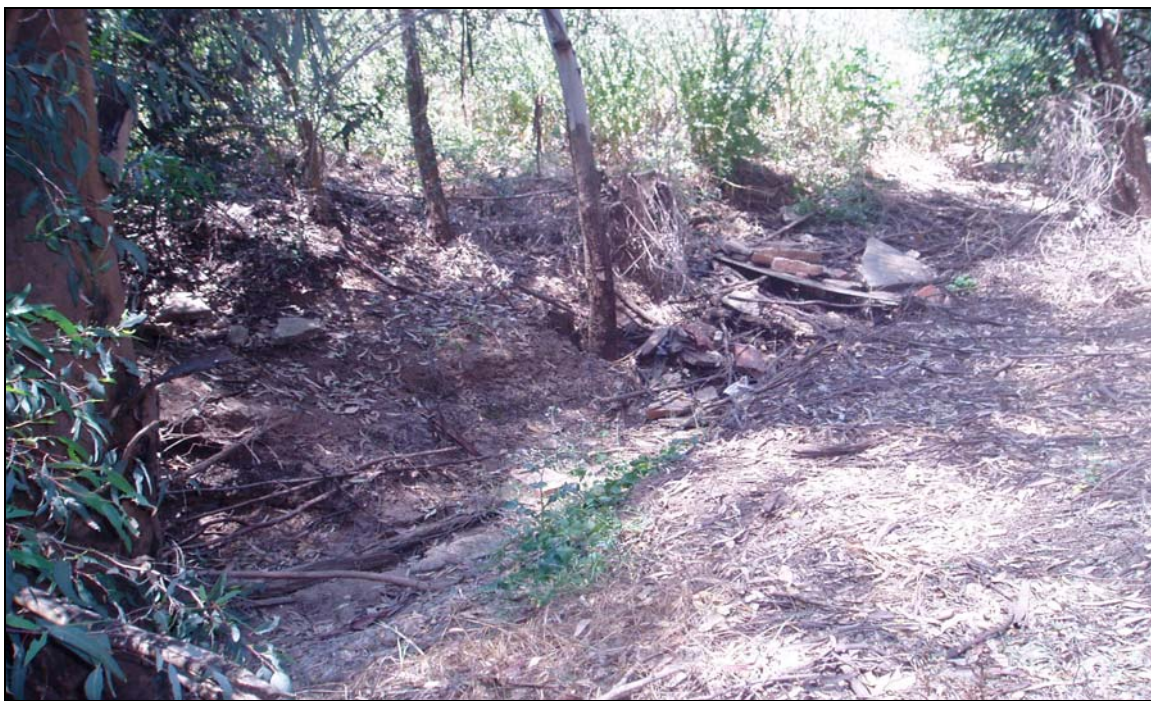
Photo Point 11. Second location along unnamed tributary of Escondido Creek between Harmony Grove Road and Escondido Creek (16 June 2005).

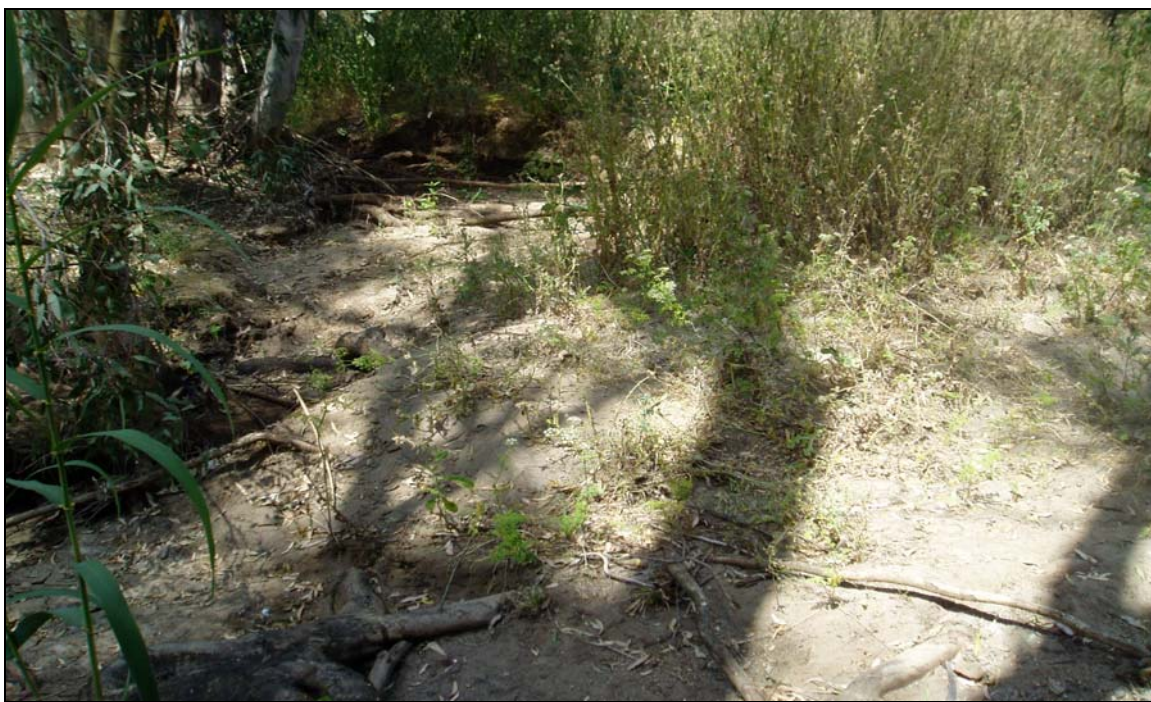
Photo Point 12. Third location along the unnamed tributary of Escondido Creek between Harmony Grove Road and Escondido Creek (16 June 2005).

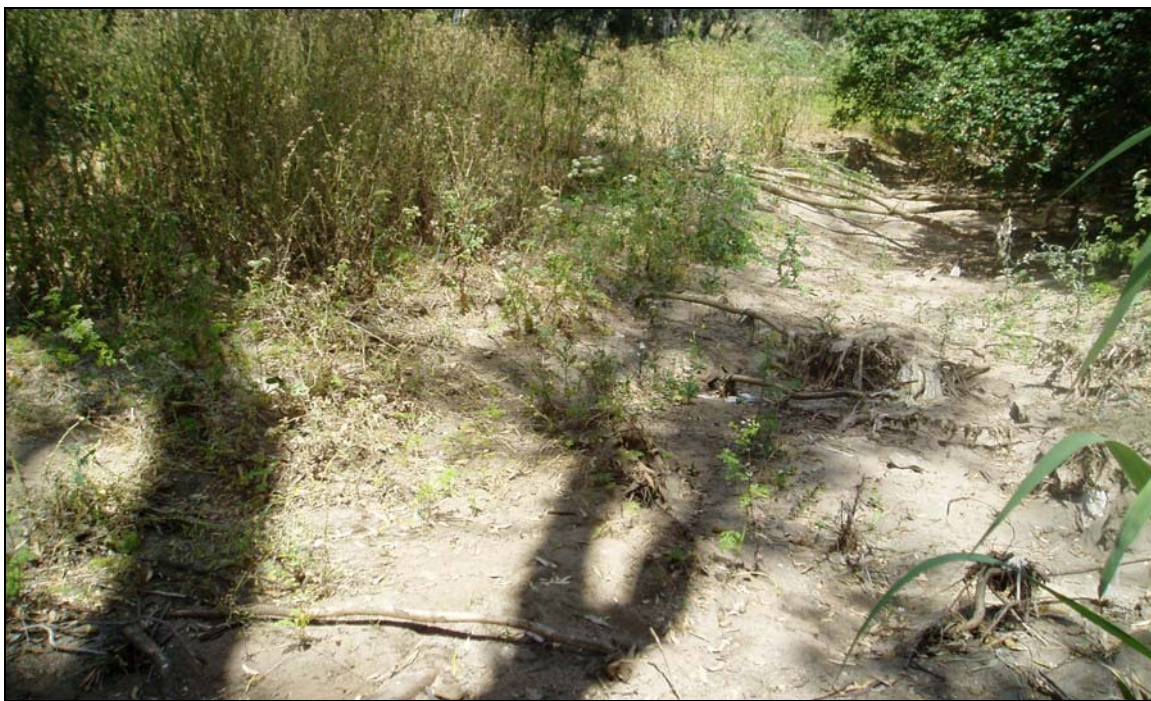
Photo Point 13. Fourth location along the unnamed tributary of Escondido Creek between Harmony Grove Road and Escondido Creek (16 June 2005).

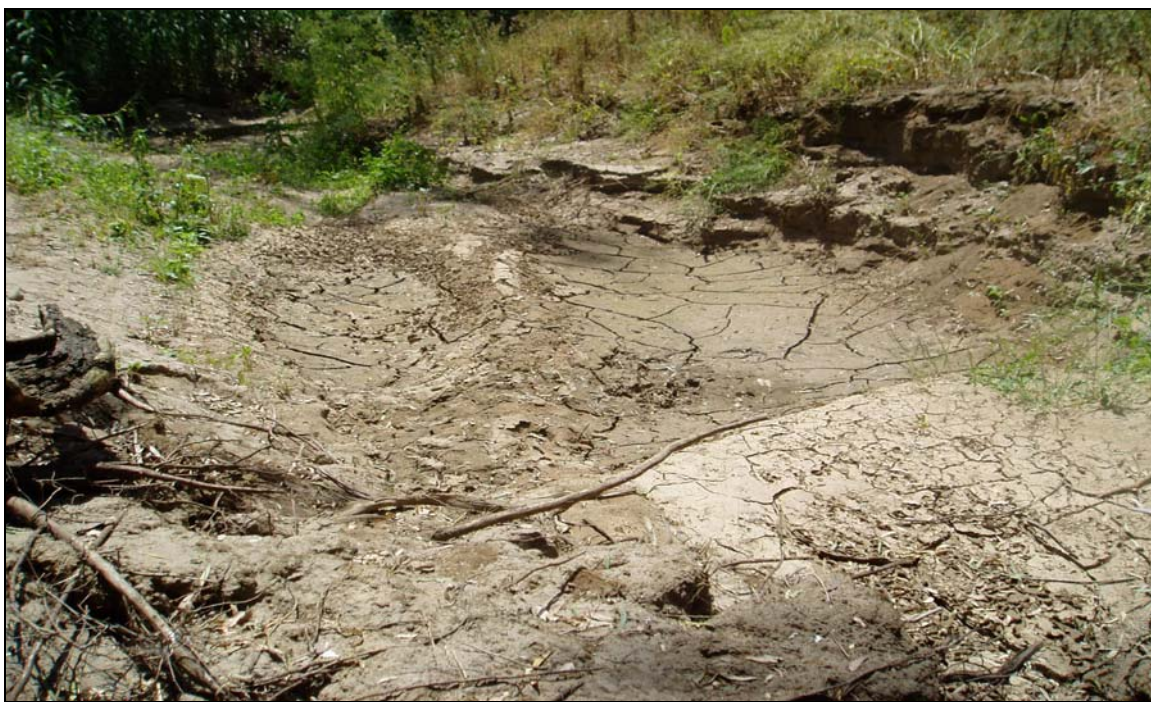
Photo Point 14. Fifth location along unnamed tributary of Escondido Creek between Harmony Grove Road and Escondido Creek (16 June 2005).

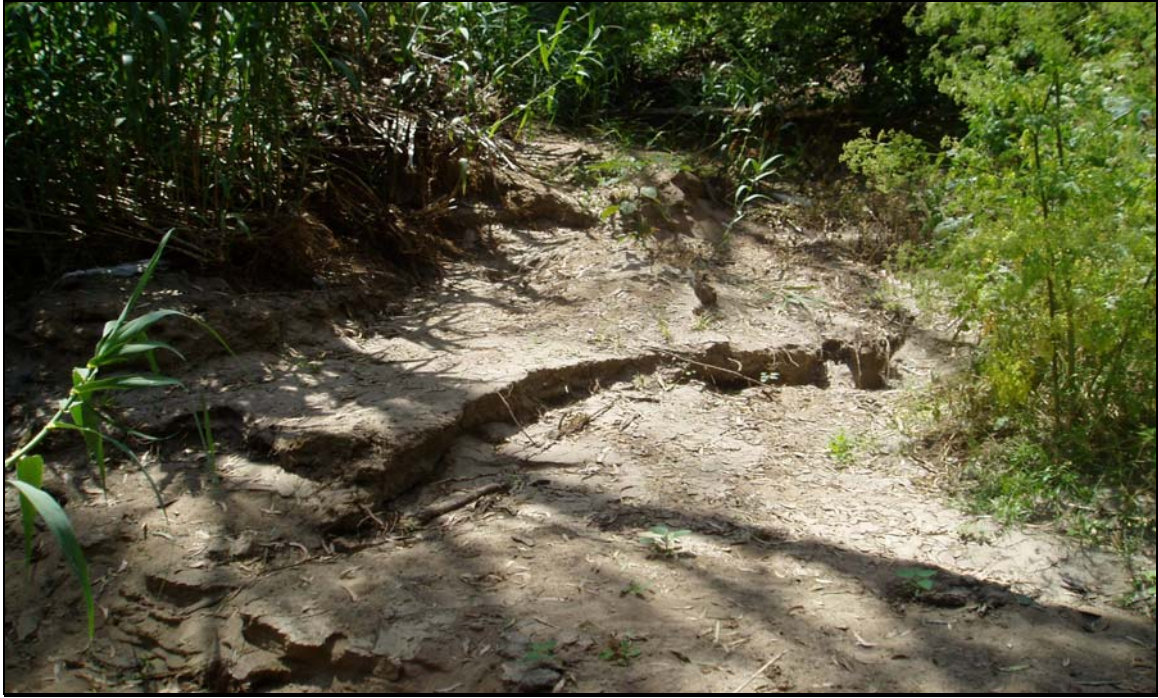
Photo Point 15. Sixth location along unnamed tributary of Escondido Creek between Harmony Grove Road and Escondido Creek (16 June 2005).

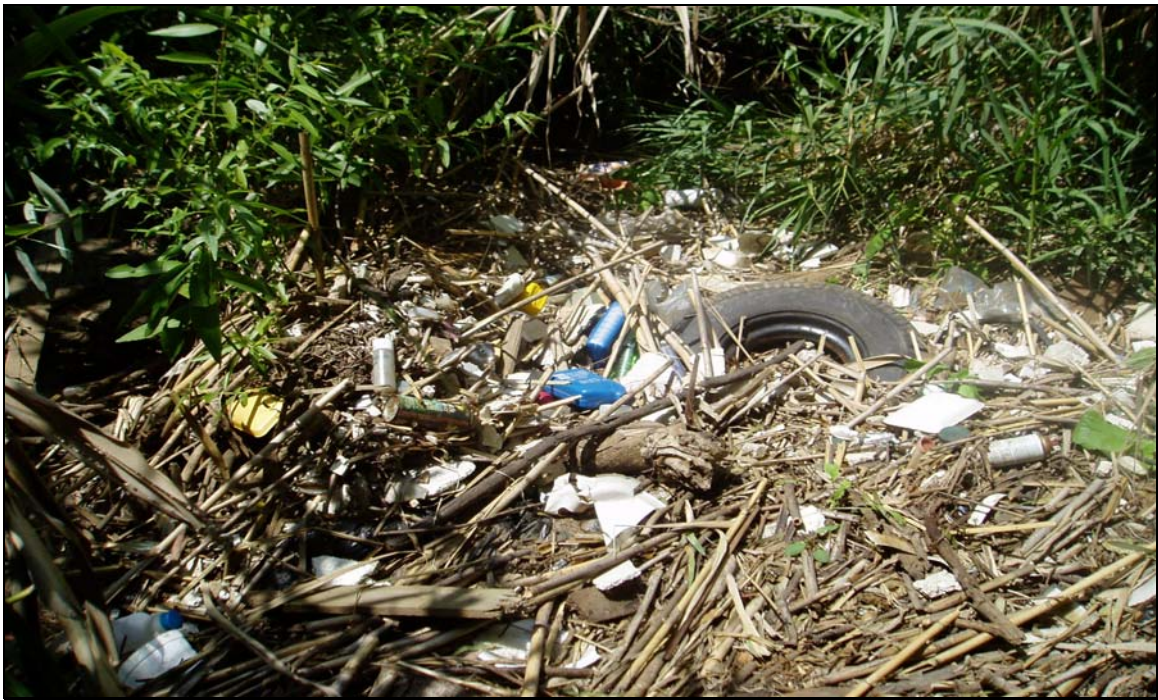
Photo Point 16. Seventh location along unnamed tributary of Escondido Creek between Harmony Grove Road and Escondido Creek (16 June 2005).

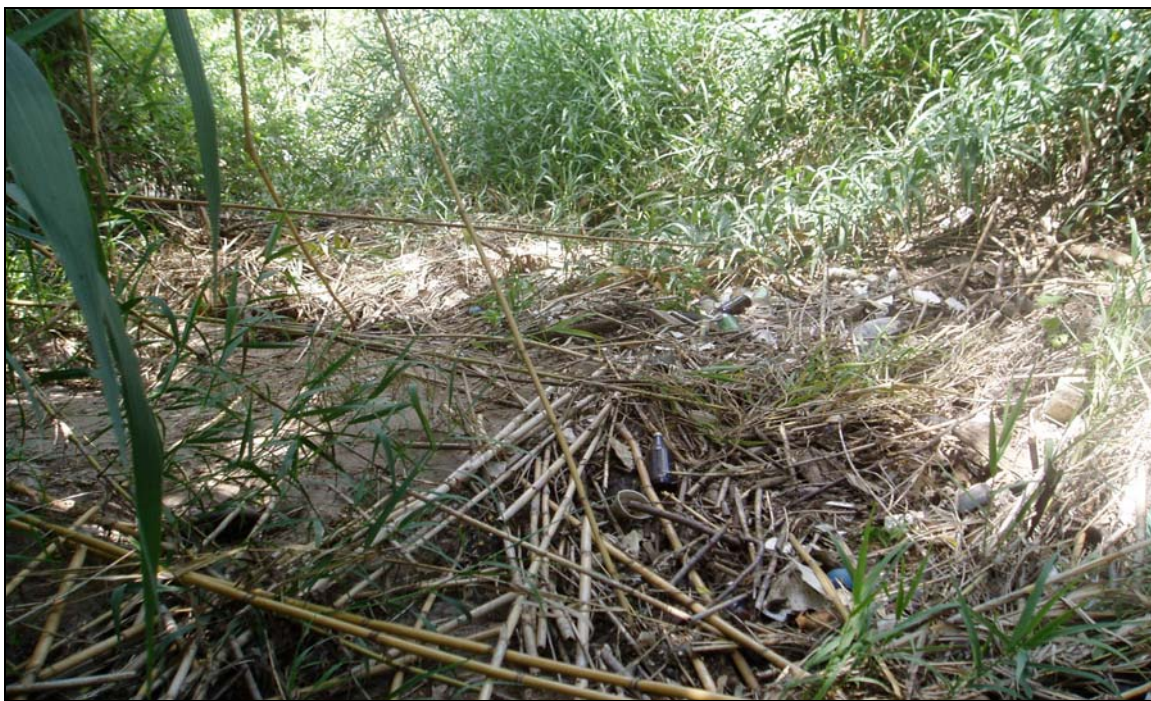
Photo Point 17. Eighth location along unnamed tributary of Escondido Creek between Harmony Grove Road and Escondido Creek (16 June 2005).

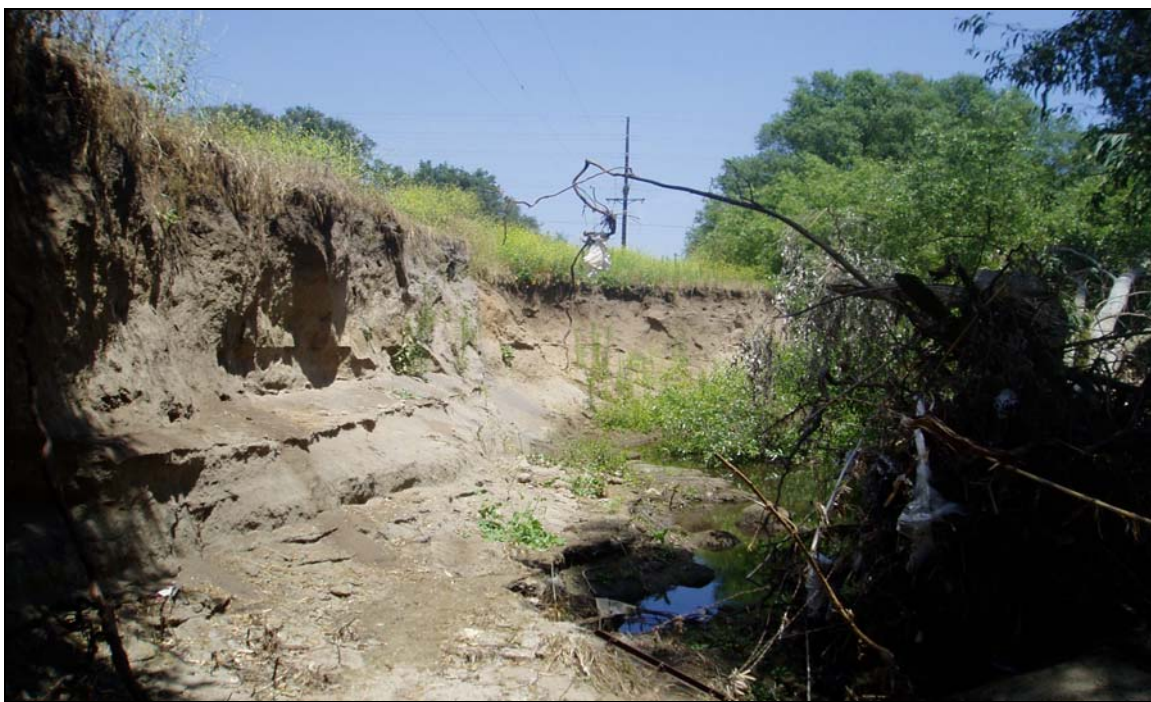
Photo Point 18. Escondido Creek upstream of confluence with unnamed tributary (16 June 2005).

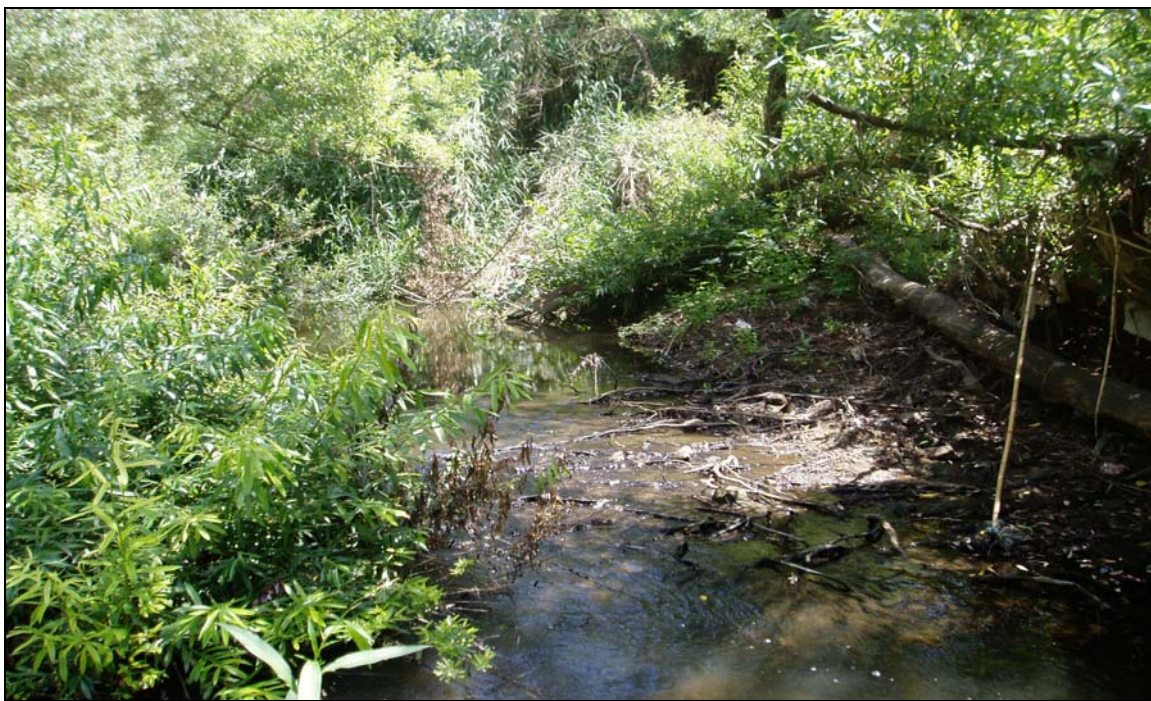
Photo Point 19. Second location along Escondido Creek upstream of confluence with unnamed tributary (16 June 2005).

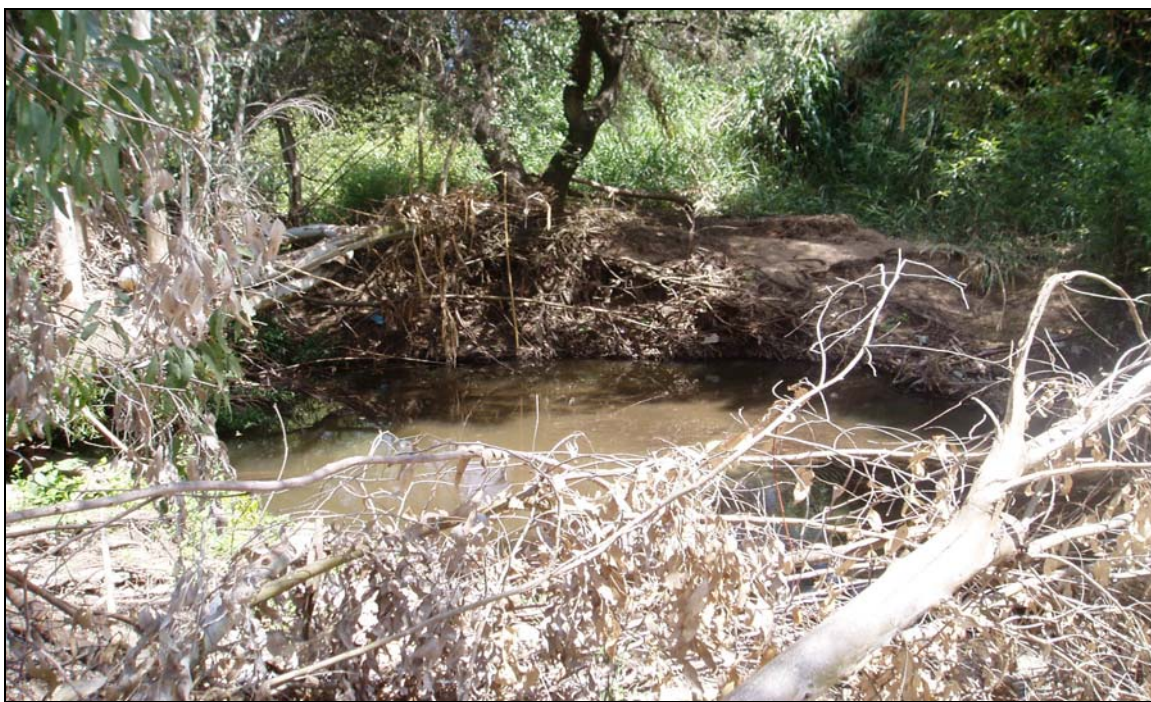
Photo Point 20. Third location along Escondido Creek upstream of confluence with unnamed tributary (16 June 2005).

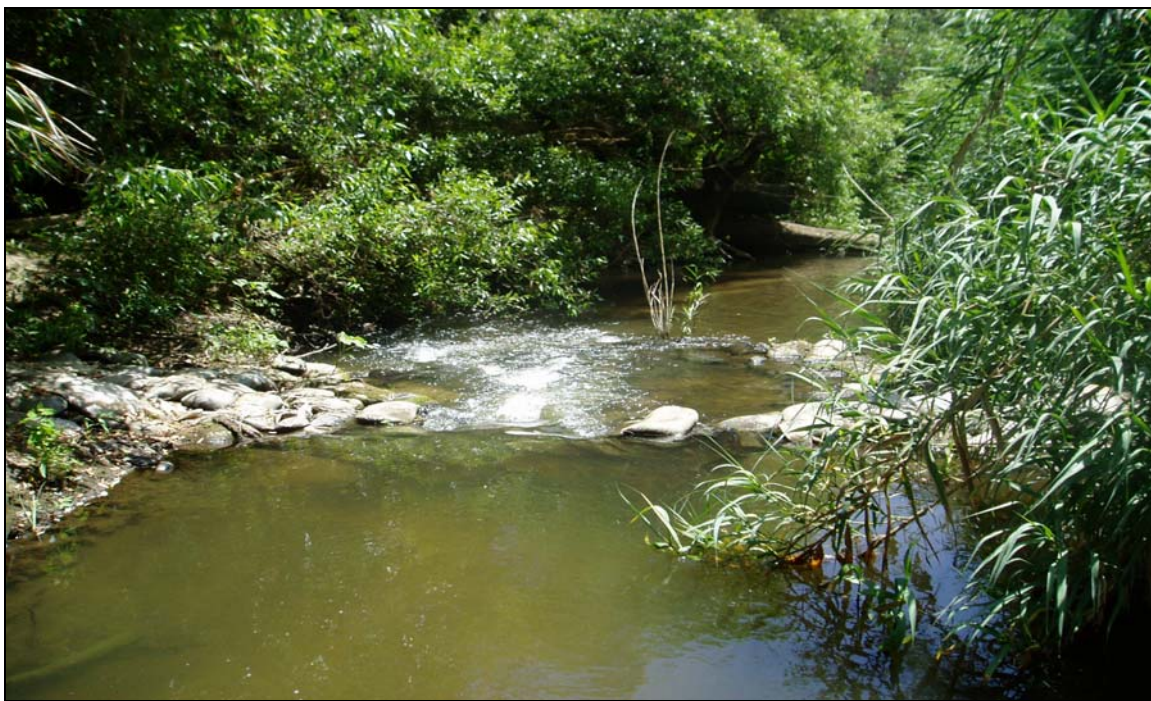
Photo Point 21. Forth location of Escondido Creek upstream of confluence with unnamed tributary (16 June 2005).

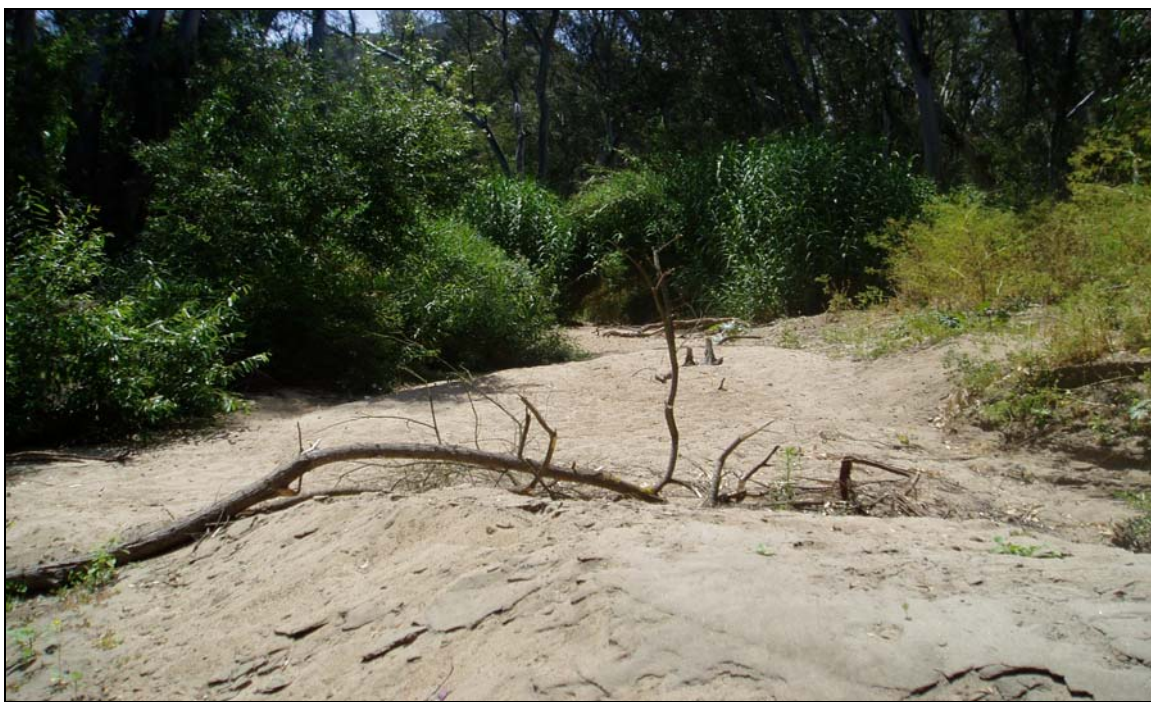
Photo Point 22. Dry secondary channel of Escondido Creek upstream of the confluence with unnamed tributary (16 June 2005).

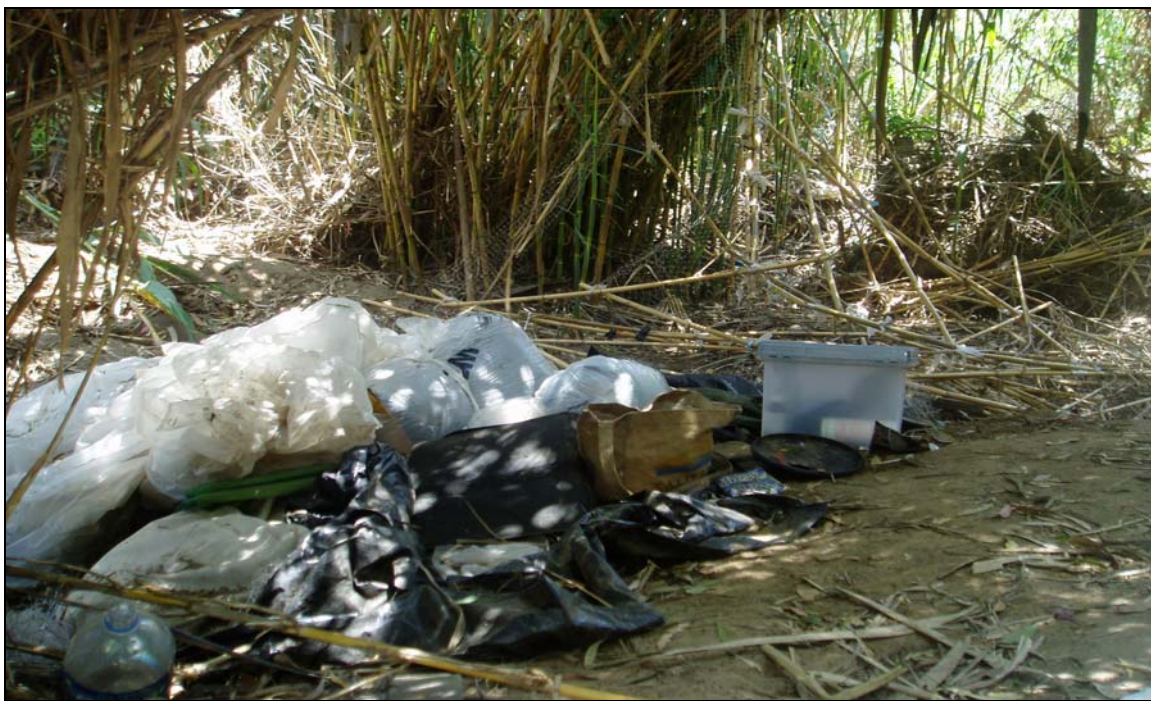
Photo Point 23. Homeless encampment in *Arundo* on a sandy bank along Escondido Creek upstream of confluence with unnamed tributary (16 June 2005).

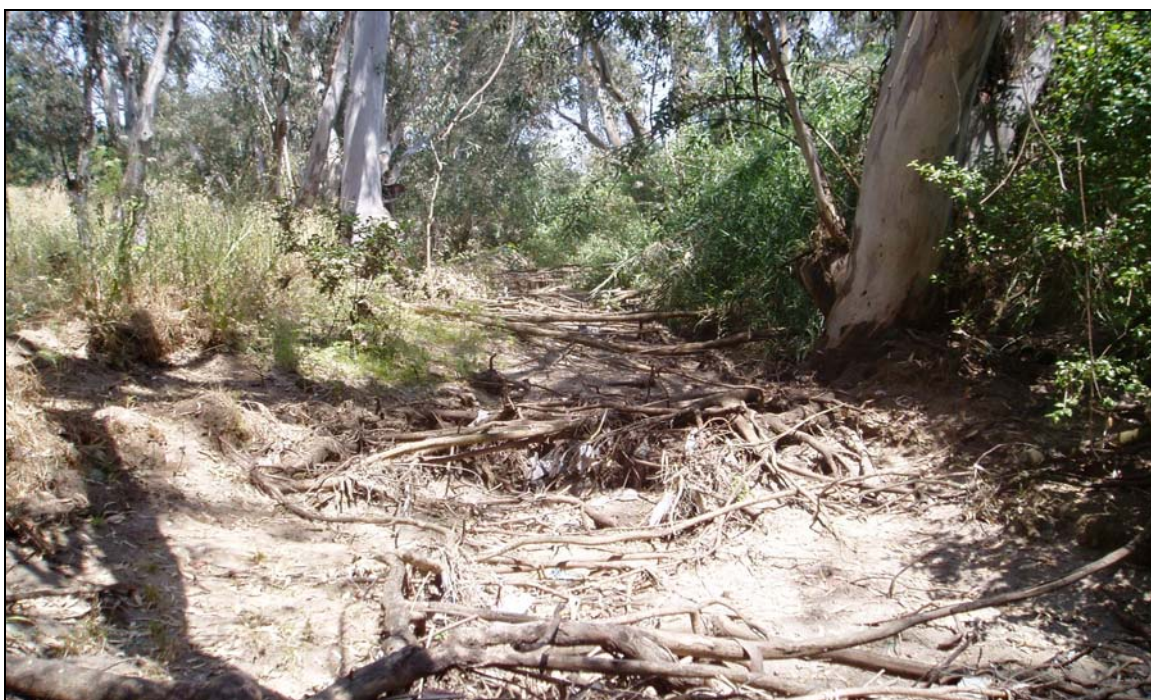
Photo Point 24. Second location of dry secondary channel of Escondido Creek upstream of confluence with unnamed tributary (16 June 2005).

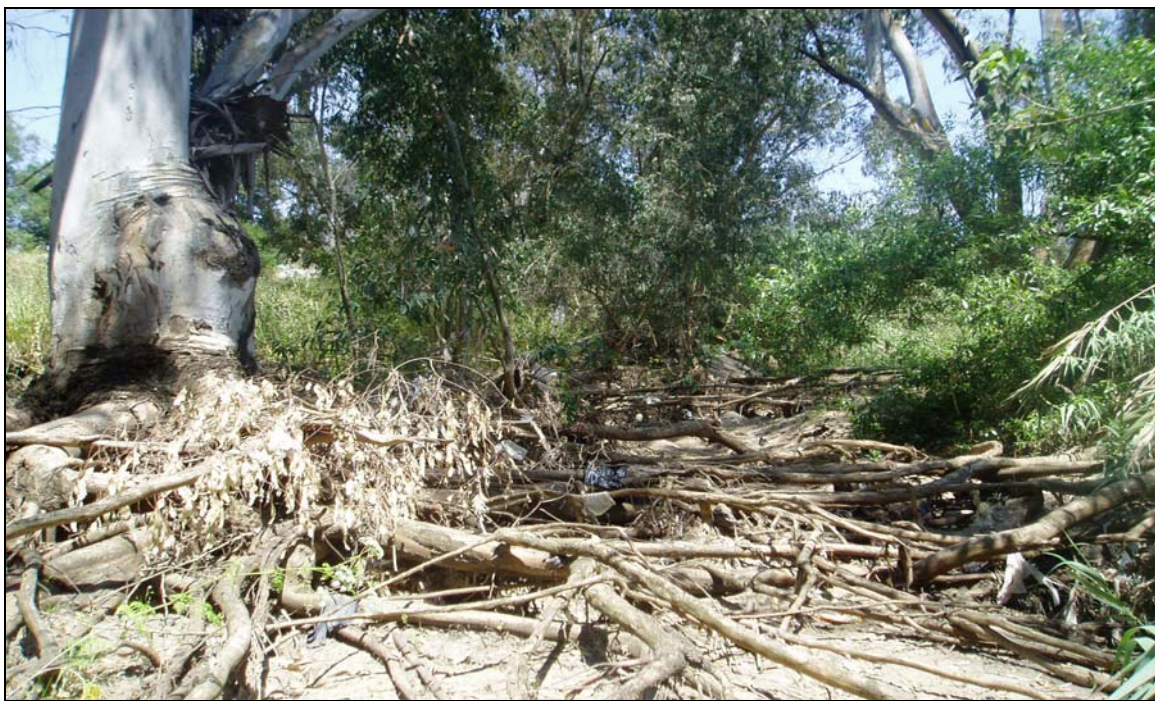
Photo Point 25. Third location of dry secondary channel of Escondido Creek upstream of confluence with unnamed tributary (16 June 2005).

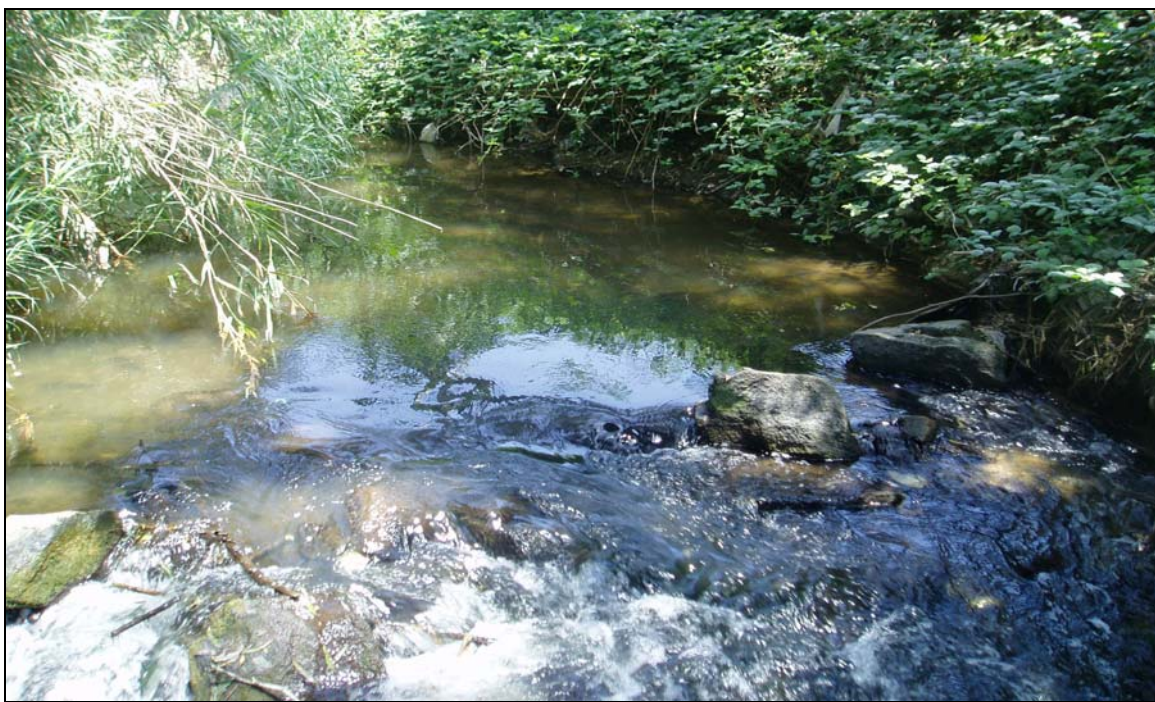
Photo Point 26. Fifth location of Escondido Creek upstream of confluence with unnamed tributary (16 June 2005).

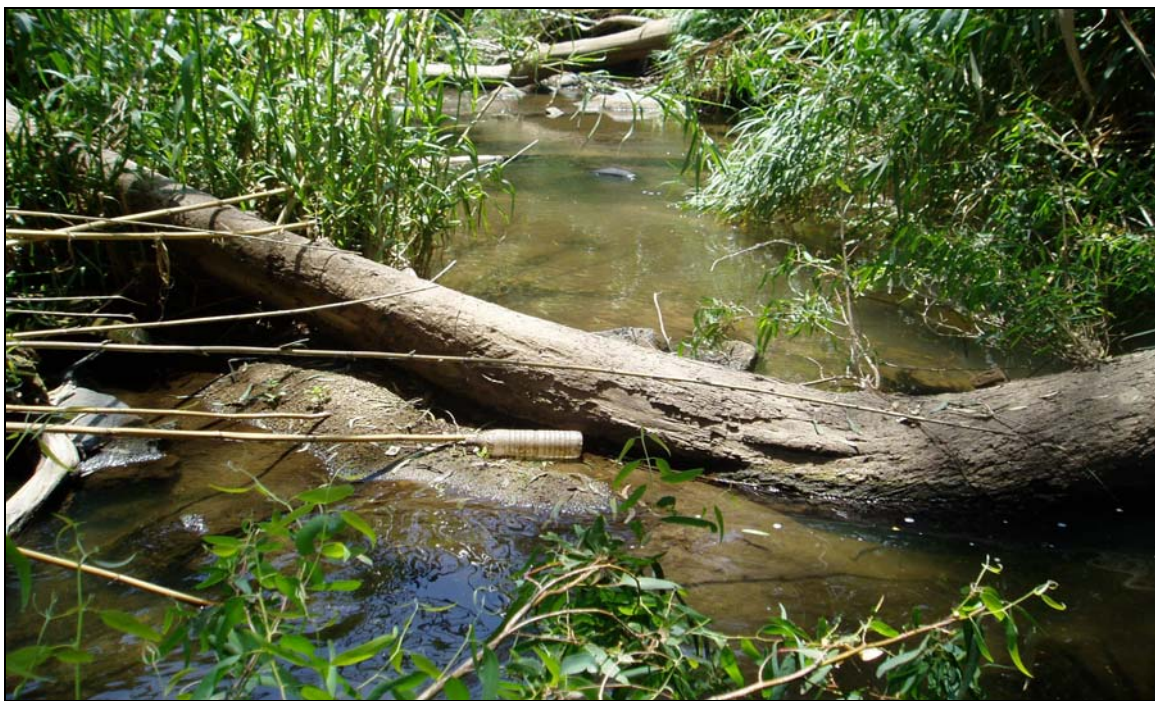
Photo Point 27. Sixth location of Escondido Creek upstream of confluence with unnamed tributary (16 June 2005).

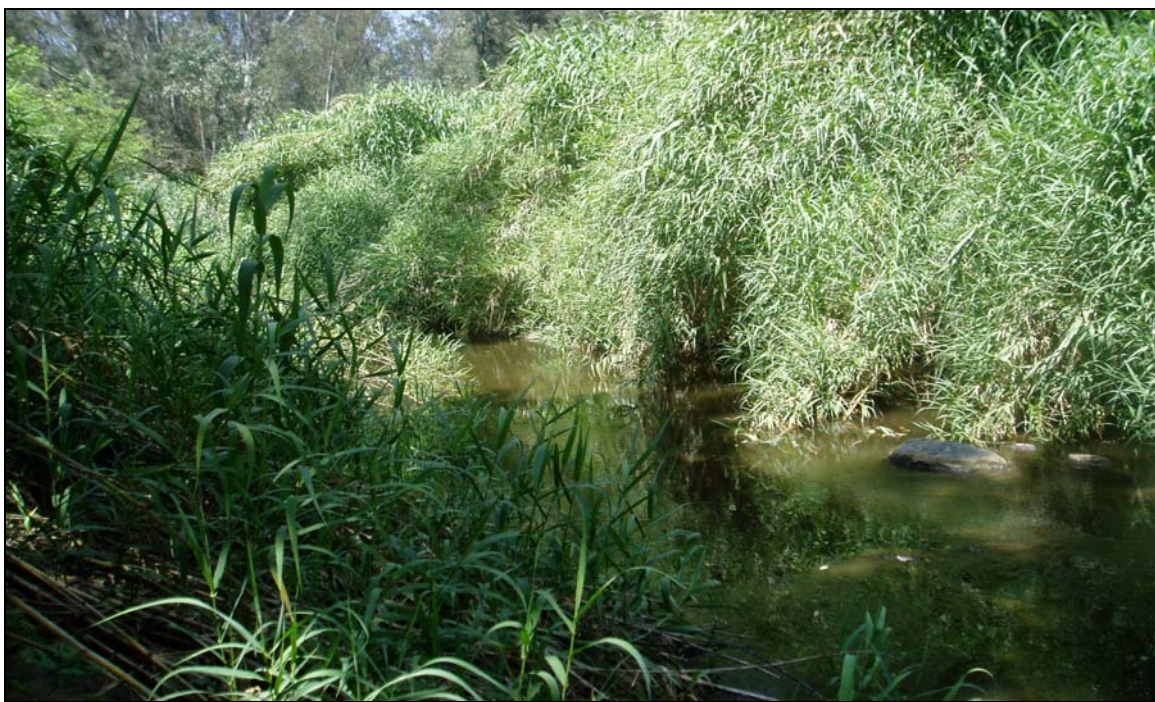
Photo Point 28. Escondido Creek down stream of confluence with unnamed tributary (16 June 2005).

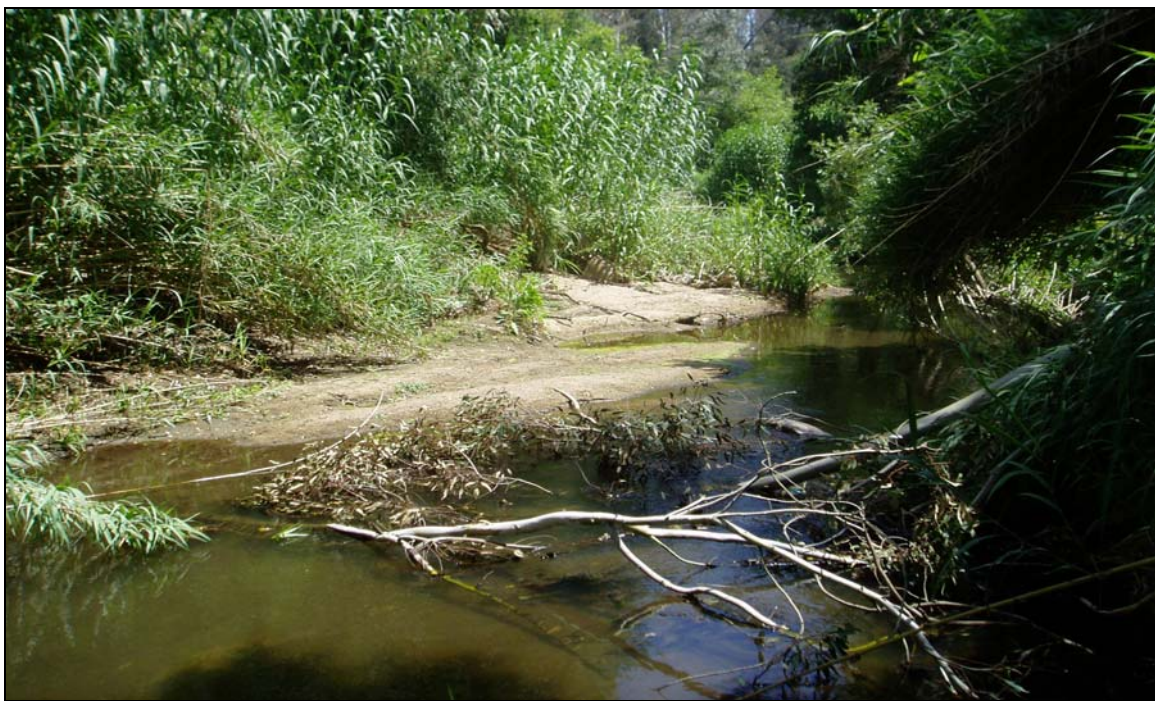
Photo Point 29. Second location of Escondido Creek down stream of confluence with unnamed tributary (16 June 2005).

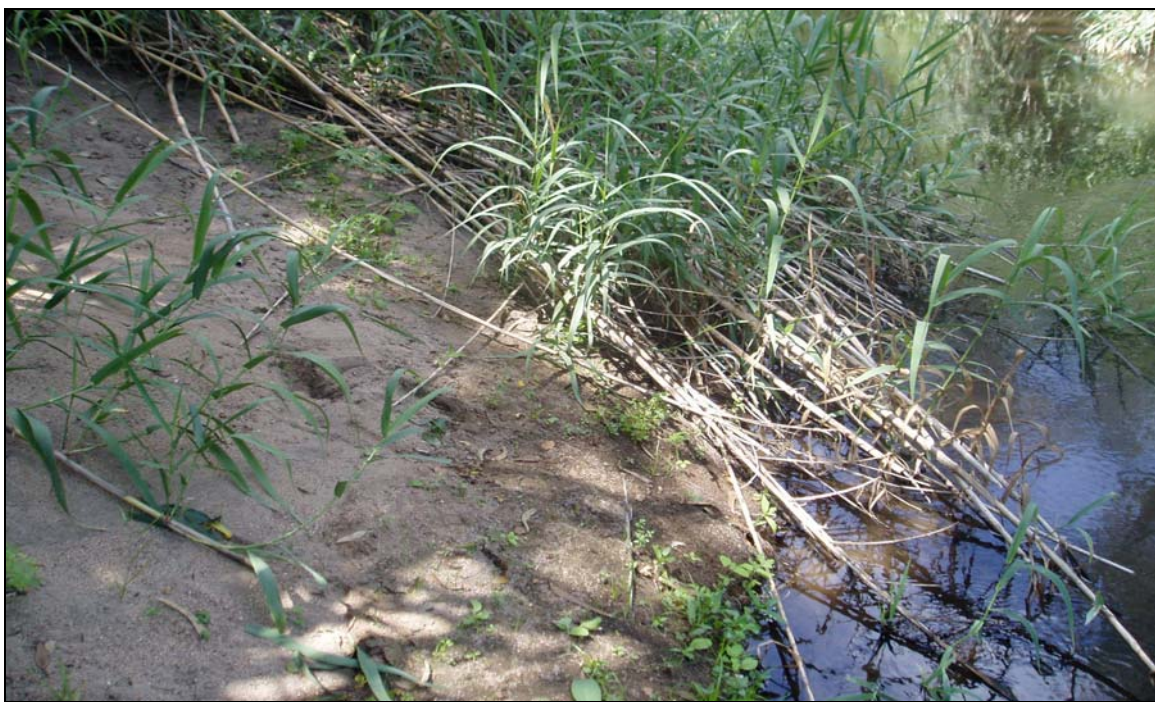
Photo Point 30. Third location of Escondido Creek down stream of confluence with unnamed tributary (16 June 2005).

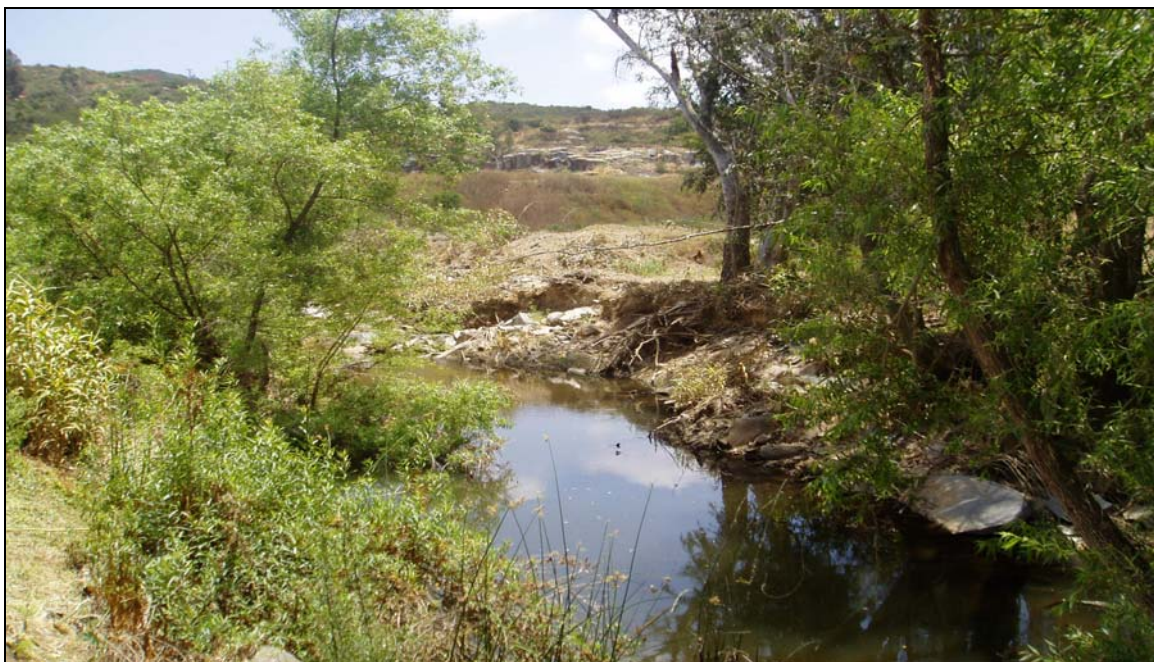
Photo Point 31. Escondido Creek in the vicinity of Country Club Road located approximately 0.8 mile down stream from the confluence of unnamed tributary (16 June 2005).

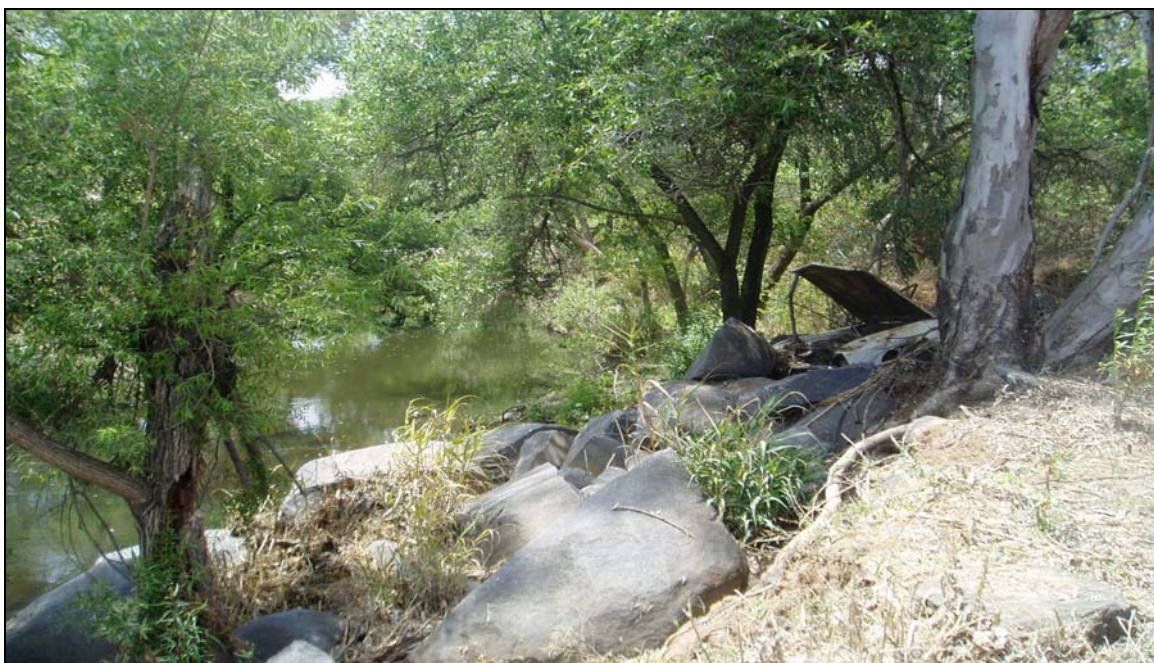
Photo Point 32. Second location along Escondido Creek in the vicinity of Country Club Road located approximately 0.8 mile down stream from the confluence of unnamed tributary (16 June 2005).

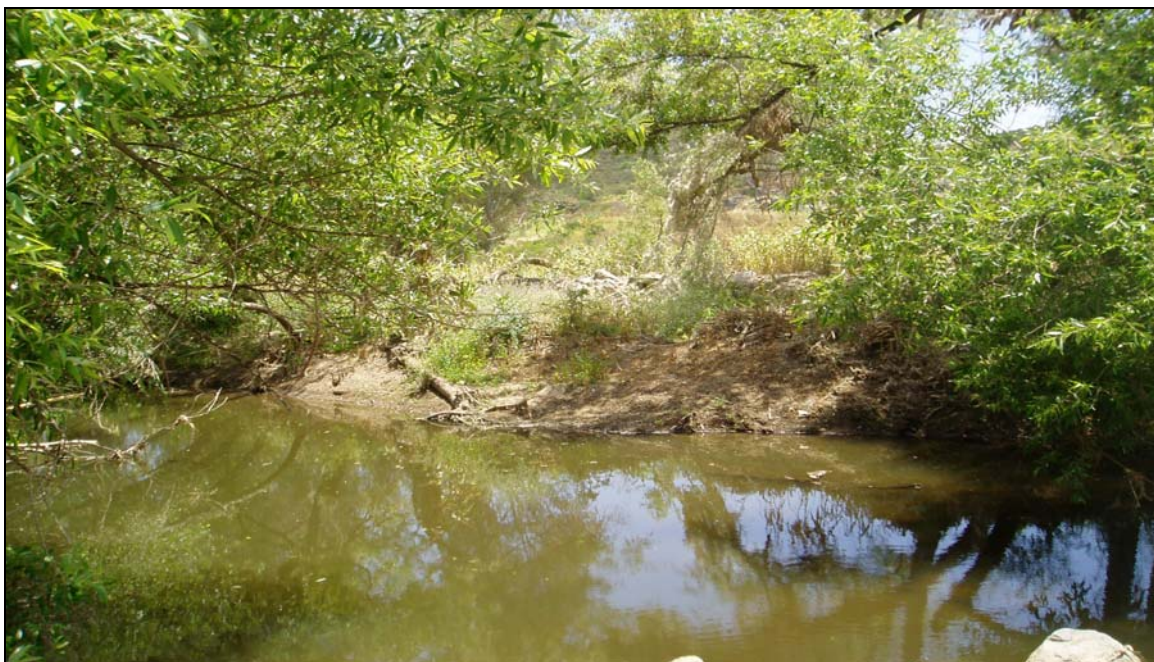
Photo Point 33. Third location along Escondido Creek in the vicinity of Country Club Road located approximately 0.9 mile down stream from the confluence of unnamed tributary (16 June 2005).
